Manhole Inspection Summary

Manhole # S27M__044MH

Insp Date: **5/5/08 2:09 PM**

Location Address: **1214 W. Ostend**

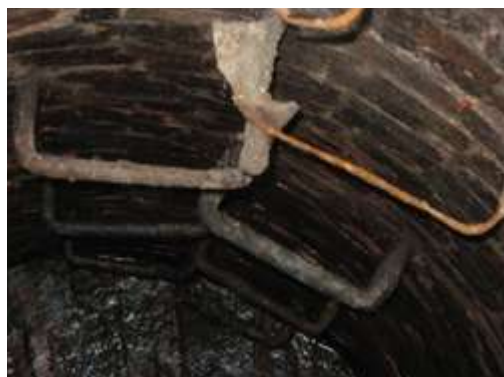
Defect 5

Surcharge ☒ Evidence Of Surcharge Depth: **5** (ft.) ☐ Active Surcharge Present

sign of surcharge

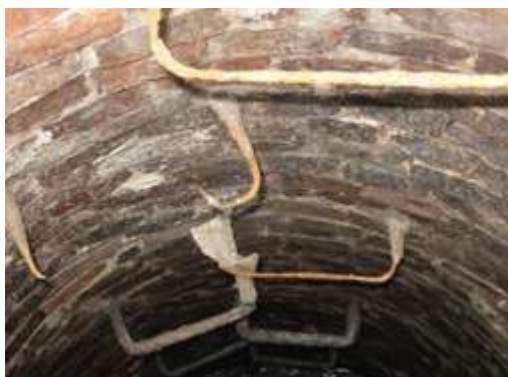
Defect 4

Steps Count: **9** Missing: **0** ☒ Corroded

miss peices of steps as well as corroded oxidized rungs

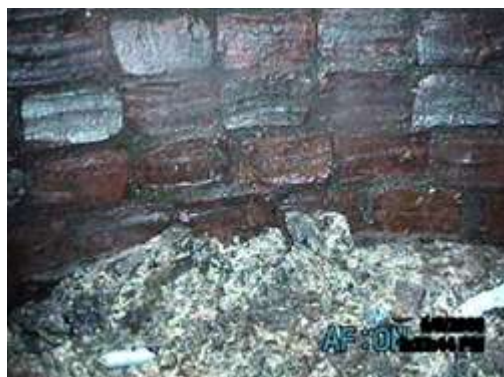
Defect 3

Condition: ☐ Sound ☐ Cracked ☐ Root Intrusion ☐ Deteriorated ☐ Leaks ☒ Debris

debris on bench

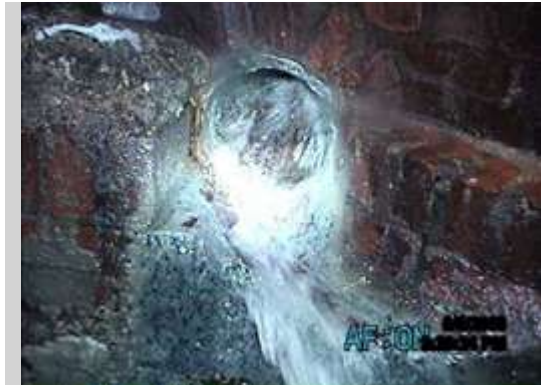
Drop In @ 9 O'Clock

Drop: **Outside** Rod and Bar

Angled: **Yes** Reading: **12.27** (ft.)

Inv Depth: **13.27** (ft.)

Drop Condition: **Partly Clogged**
